Analysis of the Increase in Water Content in Oil Lubricating Auxiliary Engine on Ships MT West Poit

This study aims to analyze the factors that cause the increase in water content in auxiliary engine lubrication oil on the MT West Point ship, as well as its impact on engine performance. The methods used in this study include regular sampling of lubricating oil, laboratory analysis to measure moisture content, and observation of the lubrication system and operational environmental conditions. The results of this study show that the increase in moisture content in lubricating oil has a significant impact on viscosity, lubrication power, and corrosion risk in engine components. Therefore, preventive measures are needed such as regular monitoring of lubricating oil quality, stricter maintenance of the cooling system, and the implementation of cleaner and safer lubricating oil filling procedures.

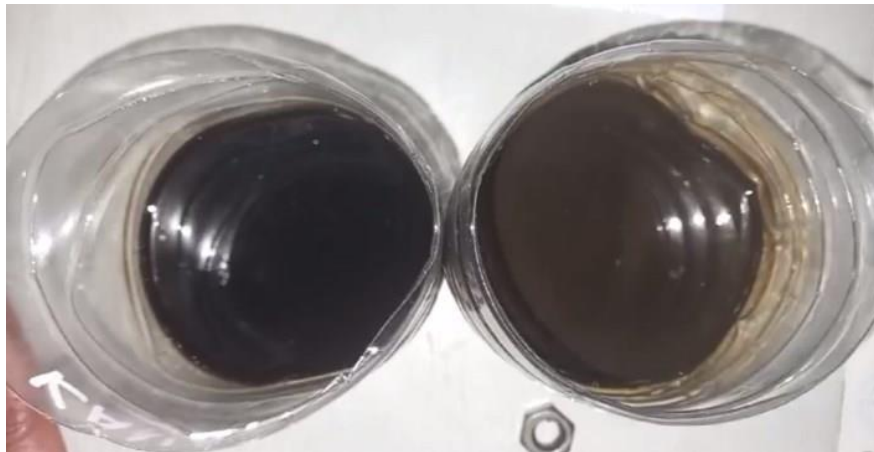
Figure 1 Comparison of lubricating oils mixed with water with normal ones

From the image it can be seen that the normal lubricating oil (on the left) appears clearer, darker, and uniform, according to the required specifications. Meanwhile, water-contaminated lubricating oil (on the right) appears cloudier, brighter, and emulsion occurs, so the quality drops and can cause problems with engine performance. Water contamination can also increase the risk of corrosion, wear, and damage to a wider extent if not addressed immediately. By carrying out proper maintenance and thorough repairs, the quality of lubricating oil can return to normal and the service life of the machine can be better maintained.

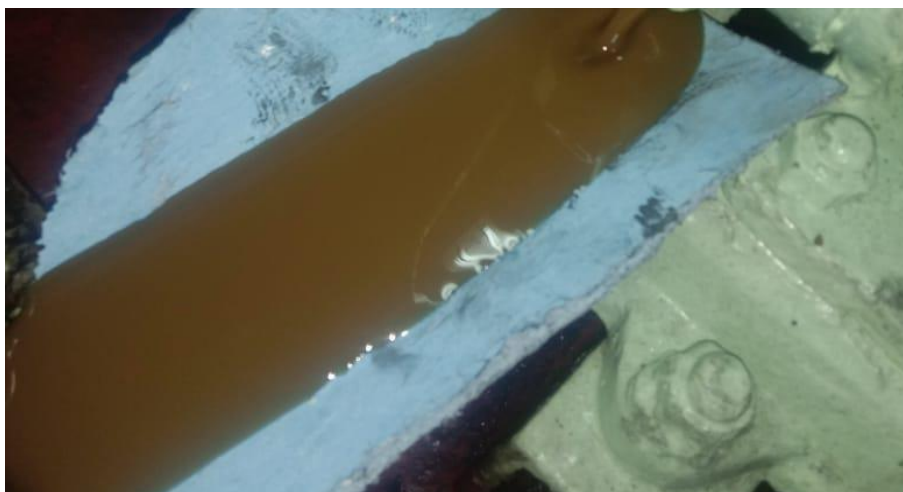
Figure 2 Lubricating oil mixed with water

Based on the visual documentation obtained, it can be seen that the auxiliary engine lubrication oil has changed color to brown with indications of water contamination, marked by emulsion in the oil. This phenomenon indicates that the lubricating oil has mixed with water,

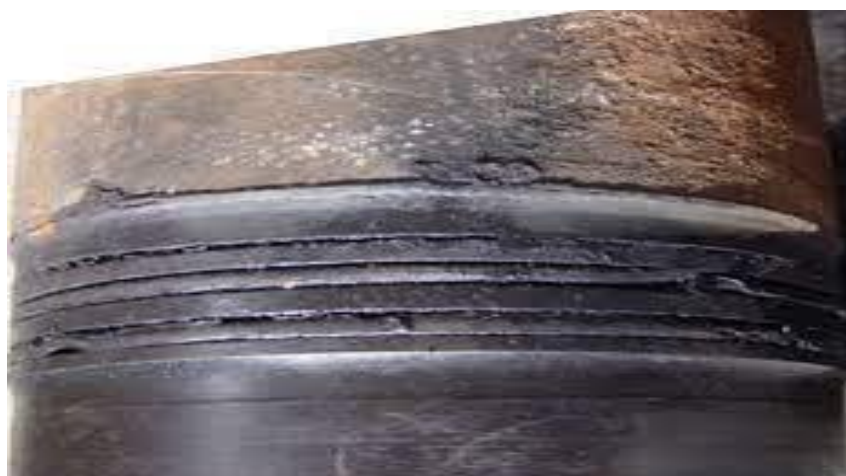
Figure 3 Cylinder Liner Wall Condition

The first hypothesis states that cracks in the cylinder liner could be the cause of coolant entering the lubrication chamber. A cracked cylinder liner will create a leaking path between the cooling chamber and the crankcase chamber, allowing water to mix with the lubricating oil. In some cases, these cracks are difficult to detect from the outside, as they are often on the inside of the liner or are micro.

However, after an in-depth inspection of AE 2, no indication of cracks or fine cracks was found on the surface of the cylinder liner. The inspection is carried out using visual inspection and dye penetrant test methods to ensure that there are no internal leaks caused by the liner structure itself. Therefore, this hypothesis is not proven in the case on the MT West Point ship, although technically it remains valid for similar cases on other ships.

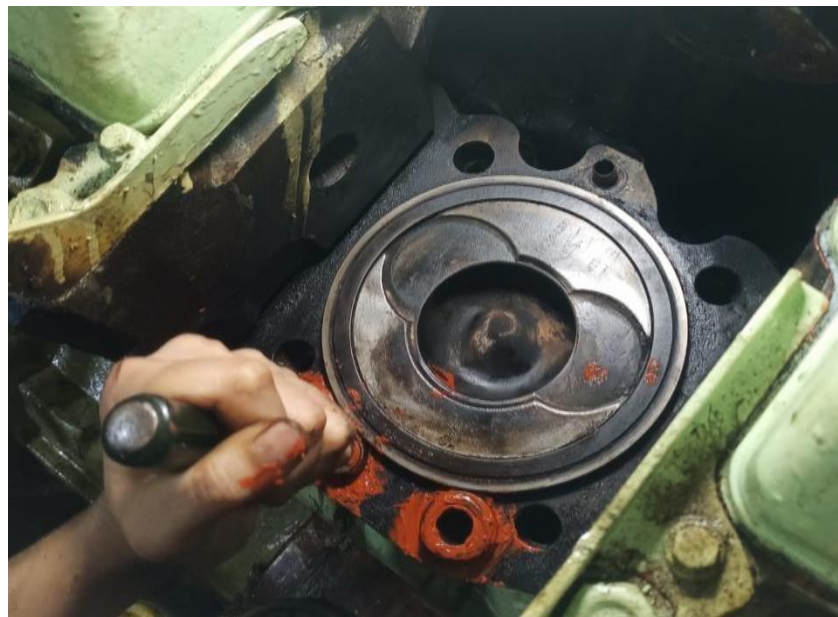
Figure 3 Suspected Damage to O ring Cylinder Join in Cylinder Head

The second hypothesis leads to damage to the O-ring joint on the cylinder head, which functions to prevent the mixing of coolant with lubricating oil in the cylinder area. If these O-rings are subjected to wear, brittleness, or imperfect installation, then cooling water can seep into the lubrication system.

At the time of repairs, it was found that the O-ring seal on the cylinder head was in suboptimal condition, but did not show a level of damage severe enough to be the main cause of water contamination in the oil. The seal function is still able to withstand pressure, even though it has undergone slight deformation due to age of use. Therefore, this hypothesis cannot be stated as the main cause, but may contribute in a minor way to the problem that occurs.

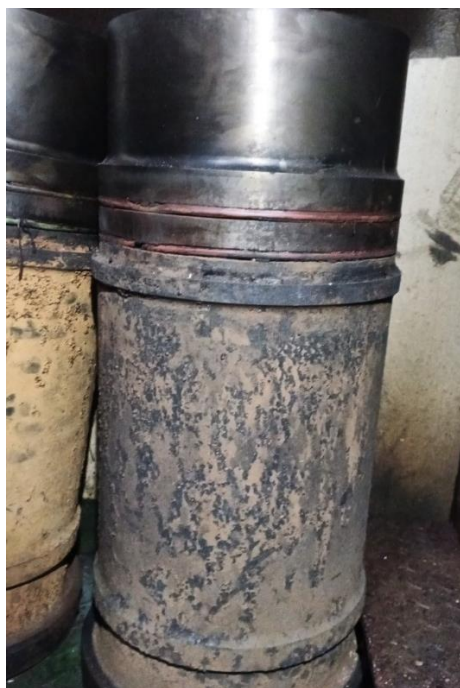
Figure 4 Oring Cylinder liner replacement

The third hypothesis states that damage and wear on the O-ring cylinder liner can cause water to enter the lubrication system. Based on the results of the inspection during the AE 2 repair, it was found that the O-rings on cylinder liners number 4 and 5 were severely worn. The O-ring has experienced brittleness, small cracks, and loss of elasticity due to long-term wear and continuous exposure to high temperatures.

This condition opens a leakage path from the cooling system to the crankcase chamber, allowing the cooling water to enter the sump tank and mix with lubricating oil. The symptoms that appear are in line with the analysis of previous data, namely the engine temperature rises, the lubricating oil pressure decreases, and there is a change in the color and clarity of the lubricating oil. Once the worn O-ring is replaced with a new one, and the lubricant is replaced, the system returns to normal function.

With these evidences, the third hypothesis is declared proven and is the main cause of the increase in moisture content in lubricating oil in AE 2. This suggests that preventive maintenance of small components such as O-rings is essential to prevent damage to the system thoroughly.

- a. Regular inspections and replacements of prone components such as O-ring cylinder liners are required, especially when showing signs of wear, to prevent water leakage into the lubrication system.
- b. It is necessary to carry out periodic monitoring of engine pressure and temperature parameters as well as the visual condition of the oil, so that the initial indication of contamination can be immediately detected and treated before it has a serious impact on the system and performance of the auxiliary machine.

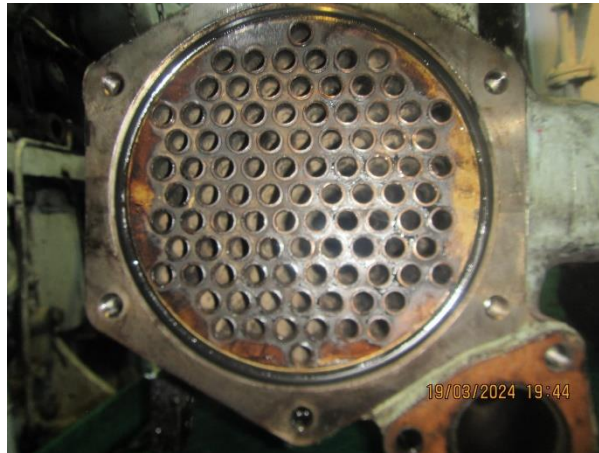
Figure 5 Alleged Leak on LO Cooler tubes

The fourth hypothesis states that a leak in the cooler's L.O (lube oil) tube can cause cooling water to enter the lubrication system. L.O coolers work on the principle of heat exchange between lubricating oil and cooling water, so that leaks in the walls of the tubes will allow water to seep into the oil stream.

During the inspection of the L.O cooler AE 2, it was found that there were indications of a minor leak in the weld joints between the tubes, but the volume was very small and not significant enough to cause severe contamination. In addition, water does not flow freely into the lubrication system, and after rewelding is performed, there are no more symptoms of leakage. Therefore, this hypothesis is considered to be a minor but not the main cause.
