Analysis Of Main Bearing Wear On Auxiliary Engine On Board Jhoni XLV

Article Info: Received march 11, 2026. Revised march 12, 2026. Accepted april 10, 2026

Citation: Rezal, M., Bahri, S., Rahman, M. S. 2026. Analysis Of Main Bearing Wear On Auxiliary Engine On Board Jhoni XLV. *Jurnal Andromeda*, 10(1), 188-196. DOI: <https://doi.org/10.48192/ard.v10i1.877>

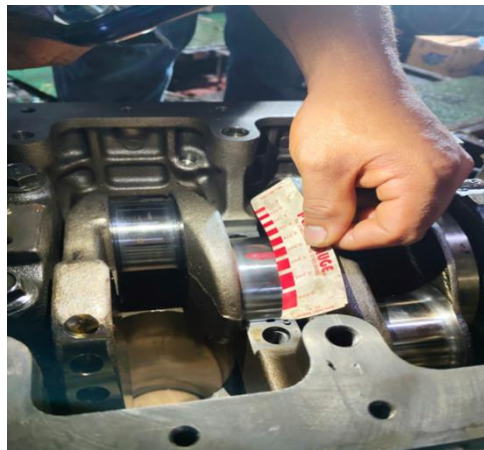
Damage to the main bearing of auxiliary engine number 2 of the JHONI XLV ship occurred due to several main interrelated factors. First, the bearing coating layer called babbitt is thinned and even peeled off in some parts. This condition makes the base metal surface of the main bearing directly exposed. The size of the gap or clearance between the crankshaft and the main bearing has also exceeded the limit determined by the factory, which is 0.19 mm compared to the maximum standard of 0.12 mm. This difference indicates severe wear. When this gap is too large, the crankshaft can move unsteadily, causing direct damage to the bearing housing, which can lead to more serious damage.

In addition, it was found that there were elongated scratches on the bearing surface which indicated direct contact due to the lack of lubricant that protected the two metal surfaces. All of these conditions indicate that the main bearing is already in a critical stage, and if left unchecked, the damage could progress faster and cause greater disruption to the engine. Damage to this main bearing risks causing the crankshaft to become misaligned, increase engine vibration, and ultimately lead to more serious component failures.

The quality of lubricating oil is very important to keep engine parts durable and functioning properly. However, in auxiliary engine number 2 of the JHONI XLV, it was found that the viscosity of the oil dropped drastically from the supposed range of 12–14 cSt, to only 9.1 cSt when tested at a working temperature of 100°C. This decrease in viscosity occurs because the oil undergoes an oxidation process, metal particles are polluted from component wear, and air ingress due to marine leaks in the ship's cooling system.

Late oil changes also contribute greatly to the damage to the main bearings. By default, the oil is supposed to be changed every 4,000 hours of operation, but the last change is only done at the 5,200th hour. Longer than standard oil usage periods accelerate the oil breakdown process, causing the oil to lose its lubrication ability and become more easily contaminated.

Figure 1. Oil clearance measurement

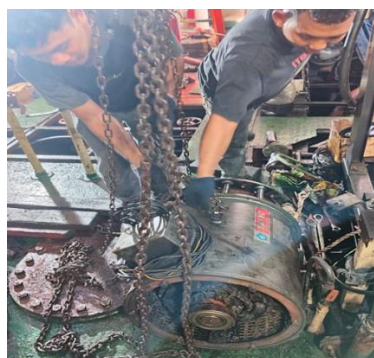
The main bearing on this auxiliary machine has been operated for more than 21,620 hours, even though the maximum limit of use recommended by the manufacturer is only 16,000 hours. This means that this component has passed about 5,600 hours beyond the safe limit. Wear that exceeds this limit makes the bearing material experience metal fatigue or metal fatigue, which leads to the appearance of microcracks, decreased durability of the babbit layer, and even exceeds the bearing.

The lubrication system clogged by carbon sludge deposition causes the oil flow to be unsmooth and the oil pressure in the main bearing drops to below 1.8 bar, well below the safe limit. This causes the oil temperature to increase to 97°C, exceeding the recommended maximum operating limit of 90°C. The obstructed oil flow makes the lubricant fail to form a good protective oil layer, eventually there is direct contact between the crankshaft and the bearing. This condition accelerates bearing wear and can cause permanent damage to the machine. This oil blockage must be addressed immediately so that the lubrication system returns to normal and the engine can operate safely.

Figure 2. Overhaul Auxiliary Engine

This condition aggravates the bearing's workload and has the potential to accelerate the complete breakdown of the components. It is important to replace the main components in accordance with the manufacturer's recommendations as a prevention so that heavy damage and operational losses can be prevented.
