Analysis of Freon Leak Identification and Repair in Refrigerator Piping System on MT GAS ALTHEA Ship

Citation: Ridwan., Winarno., Hasan. Analysis of Freon Leak Identification and Repair in Refrigerator Piping System on MT GAS ALTHEA Ship. *Jurnal Andromeda*, 10(1), 87-96. DOI: <https://dx.doi.org/10.48192/ard.v10i1.882>

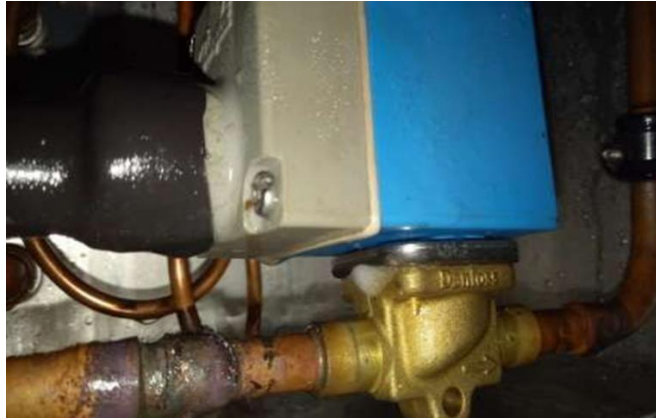
To detect the location of the leak, two methods were carried out, namely an examination with an electronic leak detector which found two active leak points at a rate of 0.3 grams per hour, and a pressure test with nitrogen which lowered the pressure from 90 psi to 84 psi for 4 hours. The leakage point is detected at the pipe connection near the expansion valve experiencing wear due to vibration, and the pipe near the receiver dryer is experiencing mild corrosion due to environmental humidity.

Corrosion in refrigerant pipes on MT ships. Althea gas is the main cause of freon leaks in the cooling system. Although the pipes use corrosion-resistant copper materials, exposure to seawater vapor, mechanical vibrations, and other metal contamination accelerates damage. Corrosion mainly occurs in areas with high humidity and limited ventilation. Physical examination found mild to moderate corrosion with fine cracks and blackened surfaces on the pipes near the receiver dryer and evaporator.

Corrosion causes micro-holes that are the source of leaks, resulting in a decrease in system pressure, compressor damage due to low workloads, and decreased cooling efficiency. The life of the pipe, which is more than six years old and mechanical vibrations that are not held back by the supports, also aggravate the condition. Corrosion prevention requires regular maintenance and periodic inspections, especially in prone areas to prevent re-leakage. Maintenance includes replacement of worn pipes, surface protection, and installation of brackets to reduce vibration.

Figure 4. Leaks In *Solenoid Valves* And Pipes In Foodstuff Refrigeration Machine Systems

Repairs begin with a thorough inspection using soap foam, electronic leak detectors, and visual inspections of leak-prone points. Defective components such as corrosion pipes, seals, O-rings, and filter dryers are replaced as standard. The pipe joints are rewelded by the brazing method with nitrogen purging to avoid oxidation.

After repair, a vacuum is carried out for 45 minutes and R-134a freon is refilled according to the system capacity. The system is pressure-tested and controlled for 24 hours to ensure operational stability. The implementation of preventive maintenance programs including pressure checks, temperatures, visual inspections, parameter recording, and technician training is carried out to maintain the integrity of the system.
