Analysis of the Declining Work of Injectors on the Combustion of Diesel Engines on Mt. Edricko 8

*Andi Fajar¹, Tony Santika², Yosrihard Basongan³,

¹ Diploma IV Program, Politeknik Pelayaran Makassar, Makassar, Indonesia

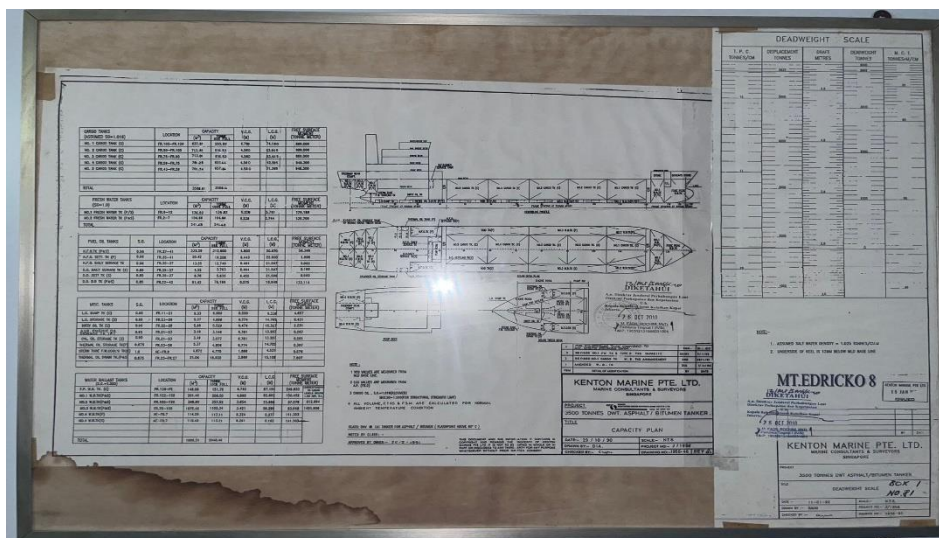
Figure 3. 2 ship particular mt. Edricko 8

Mt. Edricko 8 is a tanker that loads asphalt this ship has an overall length of 97.0 meters and a width of 15.7 meters, and has a gross tonnage of 3321 tons.

And equipped with an akasaka four-stroke main engine, type a-41, normal output of 3,300 hp x 230 rpm. And supported by auxiliary engines (auxiliary engines 1, 2, and 3) yanmar type s 165 l (420ps 1200 rpm x 3 units). Auxiliary engine 4 perkins type tu 6 3544 series (82 ps 1800rpm). The specification of the main engine fresh water cooler used in the main engine at mt.edricko 8 is type fch2f-25biu. This main engine fresh water cooler uses fresh water media to cool the main engine.

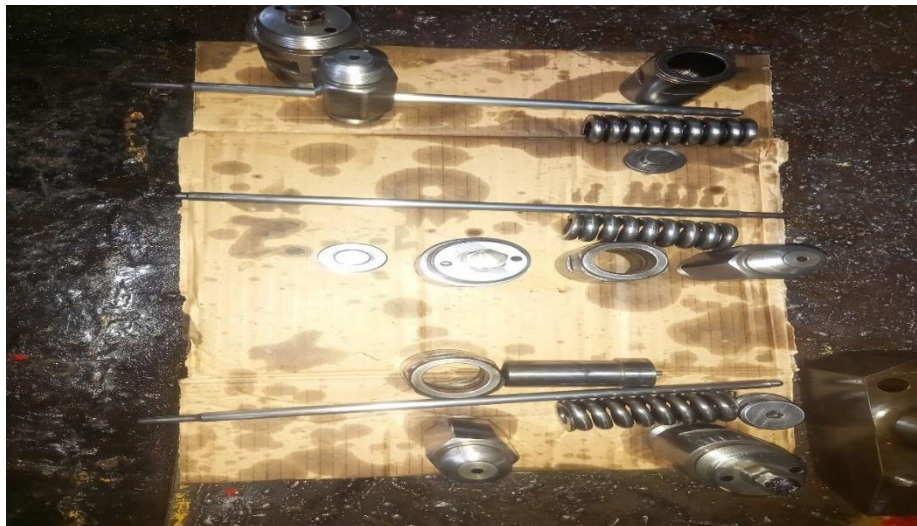
Figure 3. 3 injector components

Injectors consist of several injector components and have their own tasks and functions, for more details, here are the injector components:

- a. *Nozzle*: is spraying fine fuel, regulating spray patterns, and optimizing combustion.
- b. *Holder*: holds the *nozzle* in position, ensures proper installation, and prevents fuel leakage during the spraying process.
- c. *Spindle guide*: keeps the *spindle* shaft straight, ensures stable spindle up-down movement, and supports fuel spraying accuracy.
- d. *Spring*: functions to restore the *spindle/valve* and regulate the fuel injection pressure.
- e. *Cut-off*: stops the flow of fuel to the *nozzle* quickly and precisely after spraying is complete, preventing fuel leakage, and ensuring combustion efficiency.
- f. *Housing*: protects the injector's internal components (*such as nozzles, spindles, and springs*), provides a sturdy structure, and ensures the safe

installation of the injector to the machine

- g. The injector body houses and protects the internal components of the injector.

The fogging process begins when the high-pressure fuel from the injection pump flows through the internal line to the needle valve *nozzle*. When that fuel pressure exceeds the pressure force threshold of the regulating spring, the needle valve will be lifted from its seat. The lifting of this needle opens a hole *nozzle*, so that the fuel is sprayed in the form of a fine mist into the combustion chamber of the cylinder. Conversely, as soon as the pump stops supplying pressure, the spraying process will stop and the spring force will push back the needle valve to close the hole *nozzle* with tightness.

The amount of injector opening pressure can be adjusted by adjusting the spring tightness level via the adjusting bolt on the injector housing. To maintain the responsiveness of the system, the cavities in the body *nozzle (nozzle body)* must always be in a fully charged condition by fuel. After the spraying cycle ends, the remaining fuel that functions as an internal component lubricant and is not fogged will be reflowed. This residual fuel passes through the return channel (*return line*) to the overflow tank (*overflow tank*) to be circulated back into the system.
