## Analysis of Decrease in Sewage Treatment Plant Performance at Mt. Swordfish

The research results showed that the decline in STP performance was influenced by a lack of air supply in the tank due to a malfunctioning aeration blower/compressor, preventing aerobic bacteria from surviving. Furthermore, the suboptimal use of chlorine tablets also resulted in ineffective processing. Another contributing factor was the crew's lack of knowledge and awareness of STP maintenance and understanding of the types of waste that should be managed. Then the efforts that can be made to overcome the problem of pollution in the sea that originates from Sewage Treatment Plant (STP) namely by carrying out regular maintenance on Sewage Treatment Plant (STP) according to the procedures contained there in manual book and also socialization to the crew, both maintenance and also types of waste that can or cannot be managed.

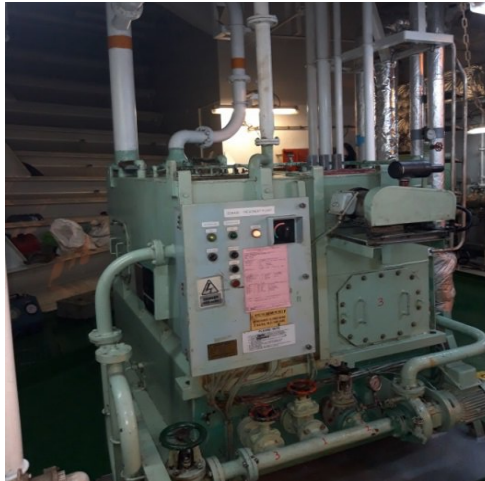
Figure 3. Sewage Treatment Plant MT.SWORDFISH

Sewage treatment plant	:	Sasakura hamworthy
Unit type	:	ST-3A
Purification process	:	Activated sludge aeration process
Rated number of person	:	38 person/day
BOD	:	Dibawah 40 PPM
Suspenden solid	:	Dibawah 40 ppm
Coliform fecal	:	Maximum 200 per 100ml
Power source	:	AC 440 Volt, 60 Hz
Compressor udara	:	1 unit
Pompa pembuangan	:	1 unit
Air diffuser	:	2 unit

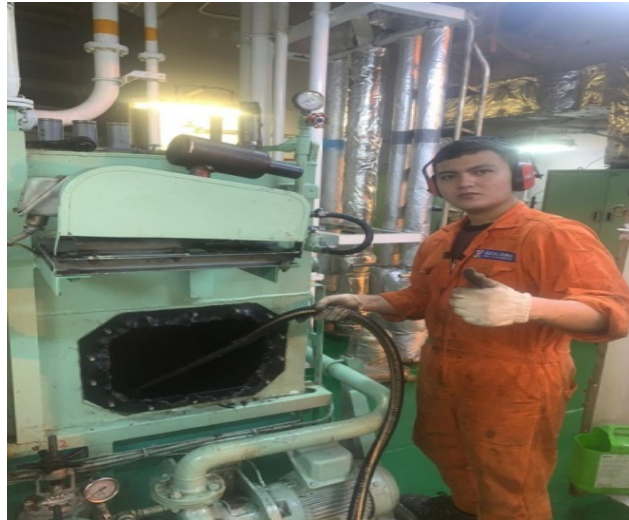
Figure 9. The author cleans the Aeration Tank

From the machine side, improper waste clogging into the tank causes the diffuser to become clogged, compressor pressure to increase, aeration to be disrupted, and waste quality to decrease.

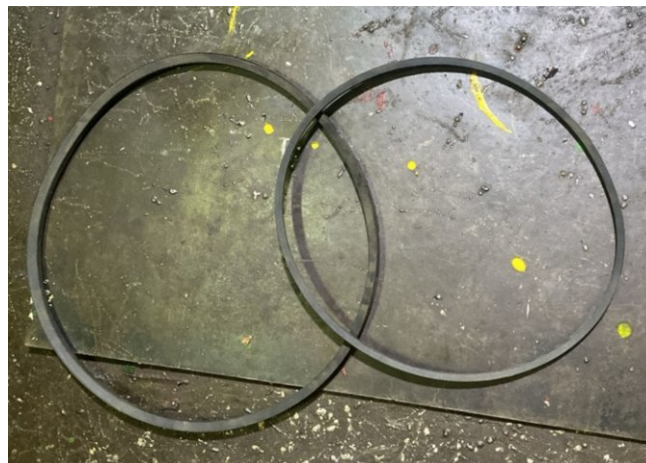
Figure 10. V-Belt Blower compressor

Material factors arise when components fail to function optimally, such as a broken compressor V-belt, which cuts off the air supply, killing aerobic bacteria and ineffective waste processing. Human factors relate to the crew's lack of attention and awareness of STP maintenance according to the PMS and weak monitoring of marine pollution.

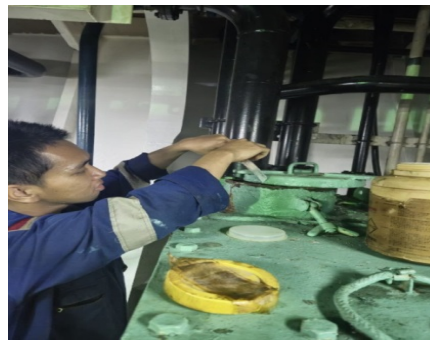
Figure 15. Oiler inserts Chlorine tablet

The decline in STP performance is caused by the irregular administration of chlorine tablets and inappropriate dosages, resulting in waste that does not meet standards and has the potential to pollute the sea.

Second, maintaining the quality of wastewater by providing chlorine tablets regularly according to the daily schedule, accompanied by the appointment of a responsible crew and the use of a daily checklist to ensure the correct dosage. Third, maintaining the performance of the blower compressor with maintenance according to the PMS, including cleaning the air filter and replacing the v-belt if it is loose or damaged, as well as maintaining other components so that the air pressure is stable and the aeration process is optimal. In addition, waste disposal is carried out according to regulations, namely to the aft peak tank when the ship is in port, and directly to the sea only when the ship is more than 12 miles from land with a minimum speed of 4 knots.
