Analysis of the Declining Production Capacity of Fresh Water Generators on MT Green Park Ships

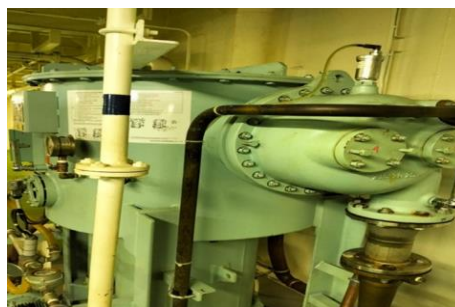
Gambar 3. Fresh Water Generator

The Fresh Water Generator on the MT Green Park ship is one of the main systems of freshwater providers with a nominal production capacity of around 3 tons per day. However, during observation and data collection, the recorded production capacity decreased drastically to 1.2 tons per day. This condition results in an inadequate water supply for the needs of the crew and other machinery equipment.
