The Effect of Leaks in the L.O Cooler Tube on Temperature Increase in the Auxiliary Engine of KM. Wilis

Citation: Ferdiansyah, W., Sarifuddin., Ivan, M. 2026. The Effect of Leaks in the L.O Cooler Tube on Temperature Increase in the Auxiliary Engine of KM. Wilis. *Jurnal Andromeda*, 10(1), 149-159. DOI: <https://doi.org/10.48192/ard.v10i1.884>

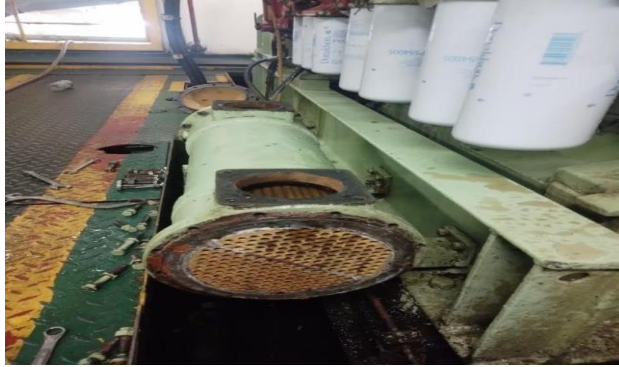
Figure 1. General View of the L.O Cooler on the Auxiliary Engine

This image shows the position and physical form of the L.O Cooler installed in the Auxiliary Engine lubricant cooling system. The L.O Cooler functions to reduce the temperature of the lubricating oil through heat transfer with a cooling medium (seawater).

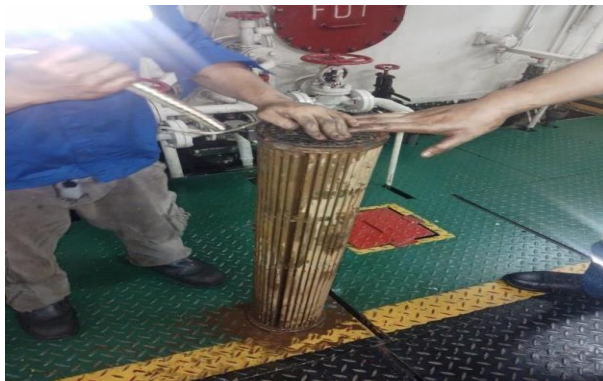
Figure 2. Leaking L.O Cooler Tube

This image shows the condition of the inside of the Lube Oil Cooler (L.O Cooler), which shows corrosion on the surface of the tube. This corrosion is suspected to be the starting point of the leak in the cooling system. This damage allows cooling water to enter the lubricating oil line, causing the two fluids that should be separate to mix. As a result, the efficiency of the heat transfer process decreases significantly and causes the lubricant temperature to rise during engine operation. This condition further impacts the Auxiliary Engine's operating temperature and reduces the quality of engine component lubrication.

- a. The main factor causing leaks in the Tube L.O Cooler auxiliary engine on the KM Wilis ship is corrosion and cracking of the tube material due to exposure to corrosive cooling water. This damage allows cooling water (fresh water) to enter the lubrication system, causing the fluids to mix. As a result, the viscosity of the lubricant decreases, the oil's ability to absorb and release heat is reduced, and heat transfer efficiency decreases dramatically. Operational data shows that the oil temperature increased from a normal range of 60°C to more than 76°C under abnormal conditions, indicating a significant decline in cooling system performance. These findings reinforce the hypothesis that the temperature increase in the auxiliary engine was caused by lubricant contamination due to a leak in the L.O Cooler Tube.

- b. Efforts to mitigate and prevent L.O Cooler leaks have proven effective when carried out through regular maintenance and operational monitoring programmes. Technical measures such as cleaning the cooling water lines of scale and dirt, pressure testing (hydrostatic test), and regular monitoring of lubricant temperature and pressure, are able to restore the stability of the auxiliary engine's operating temperature. The implementation of these measures has been proven to reduce the risk of overheating and extend the service life of the cooling system. Therefore, the operational sustainability of the Auxiliary Engine is highly dependent on the disciplined implementation of inspections and preventive maintenance of the L.O Cooler.
