## Analysis of the Causative Factors of Mt. Marisa N Crashed Mt. Victory

The purpose of this study is to analyze collisions between MT ships. MARISA N and MT. VICTORIA which occurred on April 13, 2023 at 03.00 WIB during a Ship-to-Ship (STS) transfer operation in open waters. The incident, which was investigated through observations, interviews, and analysis of ship documents at MT. MARISA N from January 2023 to January 2024, was caused by a combination of extreme weather (high waves and strong winds), miscommunication between the platform and the bow, and suboptimal maneuvers. The study concludes that to prevent similar accidents in the future, effective crew communication training, rigorous weather readiness evaluation, and consistent safety briefing are required.

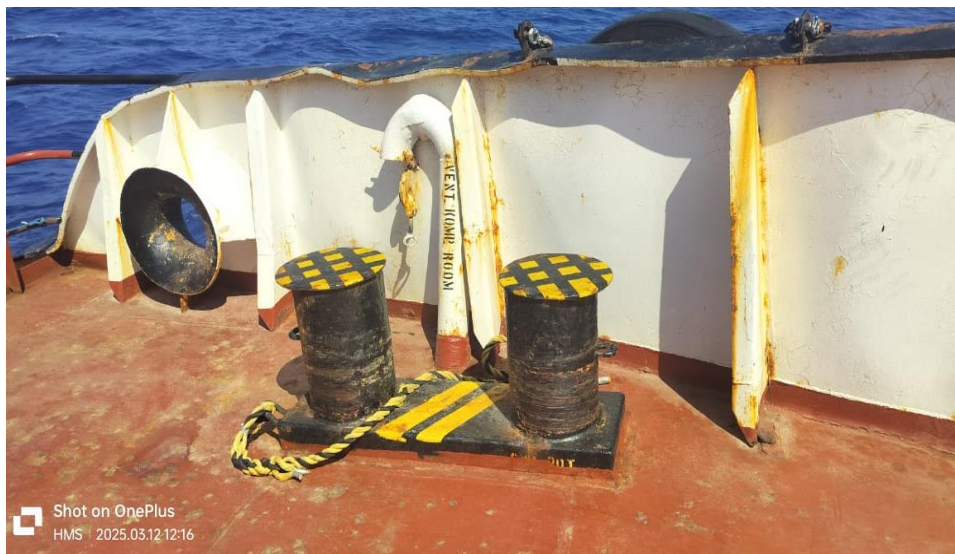
The analysis showed the collision was caused by a combination of two main factors. First, Extreme Weather Conditions in the form of high waves, strong sea currents, strong winds, and limited visibility (early morning operations) that complicate the stability and control of the ship. Second, the lack of effective communication between crews is a fatal trigger, as evidenced by the interviews of

the Captain and Mualim 1. The captain (Jafaron Shamsir) admitted that he did not carry out the safety briefing because of the urgency of the schedule and considered the crew to be used to it, which resulted in communication that did not use the close-loop system and delays in distance reporting. Mualim 1 (Rosa Usjadi) confirmed the difficulty of estimating the distance in the midst of bad weather and the inhibition of communication with the platform.

Figure 1. Collision Damage

from the bow, delayed warnings, and failure to implement a *closed-loop communication* system. The SOP evaluation corroborates that vital procedures, such as briefings and *close-loop communication*, are ignored or not optimally implemented, even when extreme weather is known. As a preventive measure, it is recommended: (1) Weather Mitigation through periodic monitoring, delay of operations when conditions are unsafe, selection of protected locations, and the use of modern navigation tools (Radar, AIS); and (2) Improving Communication through the implementation of mandatory *Safety Briefing*, strict implementation of *closed-loop communication*, appointment of Special Communications Officers, routine training, and *Master-to-Master written agreements* before STS operations.
