## **Analysis of Broken Piston Rings in the Auxiliary Engine of the MV Fatime**

**Suyuti\*, Musriady, Arifuddin Danduru, Darwis**

Marine Engineering Study Program, Politeknik Ilmu Pelayaran Makassar, Makassar, Indonesia

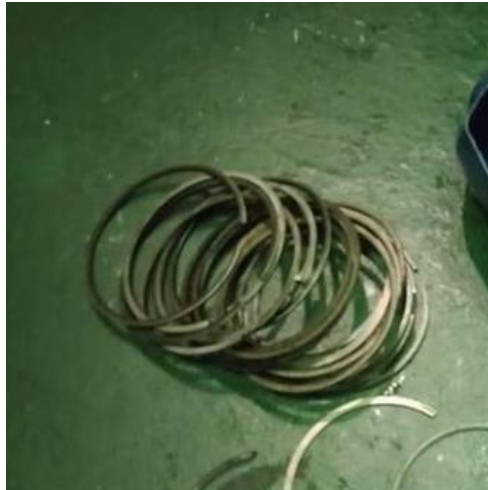
**Figure 1.** Used Piston Rings Removed from the Auxiliary Engine

On 16 December 2023, the MV Fatime left the Philippines for Muara Port, Brunei, for repairs, including the dismantling and replacement of auxiliary engine components. On 14 January 2024, during a voyage from China to Brunei, the auxiliary engine stopped. The Third Engineer found that the piston of cylinder No. 3 was sticking and reported this to the Chief Engineer. The engine was then dismantled, and damage to the piston rings was found: the compression ring was broken, causing a loss of compression and reduced combustion efficiency, and the oil ring was worn and corroded, resulting in poor lubrication and accelerated wear of other components. The Chief Engineer ordered the replacement of the damaged rings and a thorough cleaning of the cylinder head and piston to restore the engine's performance. The used piston rings are shown in Figure 1.

1. The auxiliary engine of the MV Fatime stopped because the compression ring of cylinder No. 3 broke and the oil ring was worn and corroded, which caused loss of compression and poor lubrication and led to sticking of the piston.

The broken compression ring and the worn oil ring indicate serious problems in the lubrication of the cylinder and in the combustion chamber. Maintenance such as checking the lubricating oil, changing the oil according to the standard, and checking the oil pressure regularly is therefore essential to extend the service life of the pistons and rings. The rings must be installed and sized according to the specification, and heavy operating conditions should be minimised to reduce wear. The lubricating oil used on board (reported as Shell Rimula, SAE 10W-40) should be verified against the specification of the engine maker for the Yanmar 6N165 engine, and the oil filter should be replaced together with each oil change. Regular oil analysis can further help determine the actual condition of the oil (Santana et al., 2022).

Correct installation of the piston rings is essential to prevent further damage. The procedure comprises: (1) checking the engine manual for the specification, type, and position of the rings and ensuring that the rings match the piston and

cylinder; (2) preparing a feeler gauge, a ring expander, and cleaning materials; (3) cleaning the piston, ring grooves, and cylinder of carbon and dirt and ensuring that all parts are dry; (4) inspecting the rings for cracks or deformation and measuring the ring gap with a feeler gauge; (5) fitting the oil ring in the lowest groove, with the expander first and then the scraper rings, followed by the compression rings from the bottom groove upwards using a ring expander, with the marked side (such as "TOP") facing upwards; (6) staggering the ring gaps at about 120° intervals around the piston; (7) lubricating the rings, piston, and cylinder wall with the specified oil and inserting the piston carefully using a ring compressor, pressing it gently with a wooden or rubber mallet handle; (8) rotating the crankshaft by hand to check that the piston moves freely; and (9) carrying out a compression test, recording the results, and running the engine to confirm its performance. Pinching or damaging the rings during installation must be avoided, and the maker's procedures must be followed.
