## Analysis of Tank Cleaning Implementation Using Crude Oil Washing on MT. Swordfish

Iskandar<sup>1)</sup>, Pranyoto<sup>2)</sup>, Rafael Mahesha Bintang Adhi Pratama<sup>3)</sup>, Cindy Cahyaning Astuti<sup>4)</sup>

<sup>1,2,3</sup>Politeknik Ilmu Pelayaran Semarang, Semarang, Indonesia <sup>4</sup>Universitas Muhammadiyah Sidoarjo

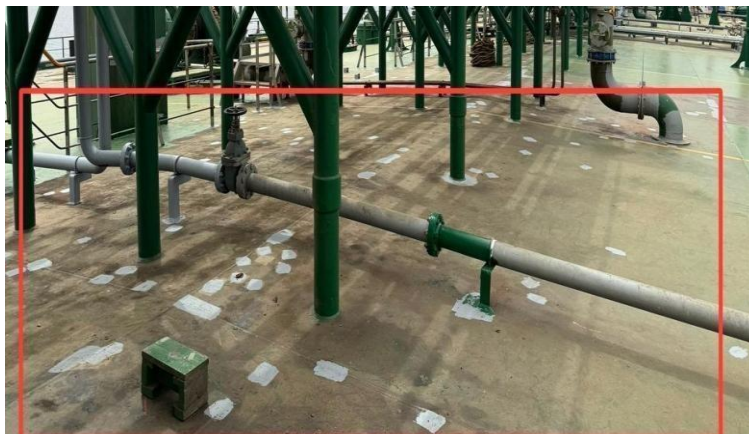
Figure 3. Repaired COW Line Pipe

Based on observations and interviews, one of the main obstacles encountered during tank cleaning using the COW method on board the MT Swordfish was a leak in the right COW line number 4 during the cleaning process of the port and starboard 4-sided cargo tanks. This incident caused an eight-hour delay in operations and had the potential to cause environmental hazards. Observations showed that the pumpman regulated the flow (line-up) from the cargo pump to the tank cleaning heater, then channeled it to the COW line on deck and sprayed it into the tank using a fixed butterworth machine with a capacity of 90 m<sup>3</sup>/hour at a pressure of 10 bar.

Interviews with the Chief Officer, Second Officer, Third Officer, Pumpman, and Able Seaman (C) confirmed that the leak was caused by old, rarely used pipes that lacked maintenance and had corroded due to exposure to seawater, rendering them unable to withstand the pressure of the crude oil flow. The Chief Officer explained that the leak occurred at the bottom of the pipe, which had been eroded by rust, while the Second Officer added that the pressure from the cargo pump exacerbated the condition of the pipe. The Third Officer, Pumpman, and Able Seaman (C) also confirmed that the age of the pipe and the level of corrosion were the main causes of the leak.

To address the problem, the crew temporarily stopped the tank cleaning process, secured the oil spill in accordance with the Shipboard Oil Pollution Emergency Plan (SOPEP) procedures, and made temporary repairs by patching the leaking section of the pipe with steel plates through welding carried out by the

Boatswain with the assistance of the Fitter on the instructions of the Chief Officer. With these temporary repairs, the COW process on the starboard side tank 4 could be resumed, while a complete pipe replacement is planned to be carried out when the ship enters dry dock.

The leakage on the starboard side of COW line number 4 occurred due to the aging of the pipe, exposure to seawater, and corrosion, which rendered it unable to withstand the pressure of the crude oil flow. This condition caused a delay in the tank cleaning process for several hours and had the potential to cause environmental pollution. To address this issue, the crew temporarily halted operations, secured the oil spill in accordance with SOPEP procedures, and made temporary repairs by patching the leaking section of the pipe with steel plates using welding. This action allowed the tank cleaning process to continue safely while awaiting permanent pipe replacement when the ship entered dry dock.

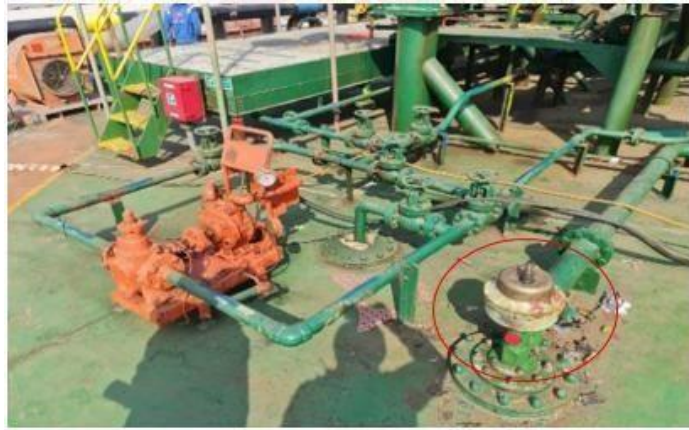
Figure 4. Butterworth Machine

In addition, another obstacle was the malfunctioning of several fixed butterworth machines. Based on observations and interviews, it was found that during the tank cleaning using the COW method on board the MT Swordfish, several fixed butterworth machines were unable to move automatically, particularly on the port side 1 tank, port side 3 tank, and starboard side 6 tank. This condition was caused by rust buildup on the gears due to lack of maintenance and infrequent use of tank cleaning equipment, resulting in a jam in the water jet drive mechanism.

To overcome this problem, the crew, under the instructions of the Chief Officer, inspected the gears, lubricated them with grease, and operated the butterworth machine manually using a ring spanner until the equipment could function temporarily. This action ensured that the tank cleaning process could continue to run effectively, while the problematic equipment was marked for replacement when the ship entered dry dock. Additionally, during the inspection process, the crew discovered slight wear on the gear teeth, indicating the need for preventive maintenance and emphasizing the importance of regular equipment inspection and operation to prevent similar operational delays in future tank cleaning procedures.

Several fixed Butterworth engines cannot move automatically due to corrosion on the gears caused by lack of maintenance and infrequent use of tank cleaning equipment. This condition reduces the effectiveness of spraying and has the potential to slow down the cargo tank cleaning process. As a countermeasure, the crew cleans the rust on the gears, lubricates them with grease, and operates the engine manually using a ring spanner.

Although this is only a temporary measure and movement is limited, it allows the tank cleaning process to continue until repairs or permanent component replacement is carried out when the ship enters dry dock.

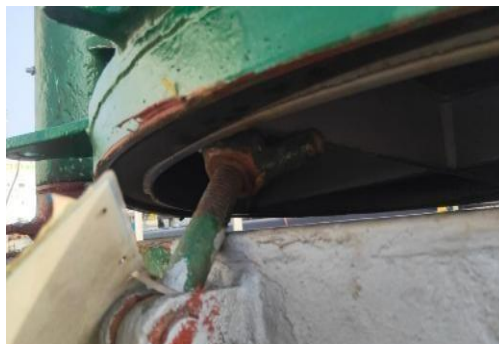
Figure 5. Condition of Rusty Manhole Threads

In addition, researchers also found rust on the wheel thread of the manhole cover and on the butterfly purging pipe valve thread. Based on observations and interviews, researchers found obstacles in the gas freeing stage of the tank cleaning process on the MT Swordfish, namely difficulties in opening the cargo tank manhole cover and purging pipe due to rust on the wheel threads and butterfly valve threads. This condition caused the threads to jam, so that the process of opening the manhole and purging pipe took longer and resulted in a delay in the gas freeing process for several hours. The rust was caused by a lack of maintenance of the tank cleaning support equipment and the influence of external factors, such as exposure to seawater and rainwater. To overcome this obstacle, on the instructions of the Chief Officer, the crew cleaned the rust using a wire brush and WD-40 liquid, then lubricated the threads with grease. Next, the purging pipe was forcibly opened using an iron rod, while the manhole cover was opened with the help of a tackle so that the wheel could rotate. Although the gas freeing process was delayed, these efforts successfully overcame the obstacles so that the next operational stages could still be carried out.

Rust on the threads of the manhole wheel and butterfly valve purging pipe caused difficulties in the opening process, slowing down the gas freeing stage. This problem was caused by a lack of maintenance and continuous exposure to seawater and rainwater. To overcome this, the crew cleaned the rust and lubricated the threads, then opened the components manually with the help of additional tools such as iron rods and hook tackle. Although it required more time and effort, these efforts successfully enabled the gas

freeing process to continue, while emphasizing the importance of routine maintenance and inspection of tank cleaning support equipment.
