## ROOT CAUSE ANALYSIS OF DIESEL GENERATOR BLACKOUT DUE TO FUEL RACK MALFUNCTION ON MV SINAR SORONG

The electricity of a ship greatly depends on diesel generators, which depend on the fuel system to be effectively combusted. This study examines a ship blackout incident that was occasioned by a huge disparity in exhaust gas temperature in a diesel generator. Data were collected by observing, interviewing, documenting and reviewing the literature using a qualitative descriptive design and Fishbone diagram as a tool of analysis. The root cause of the study has been cited as failure in combustion in one of the cylinders brought about by mechanical slip in the fuel rack system. Results show that problems in the delivery of fuel, including leakages in the pipes, corrosion, stuck fuel racks, and poor monitoring cause imbalances during combustion. Such imbalances increase the exhaust temperatures causing extreme degradation of performance and resultant blackouts. To avoid the occurrence in future, ensure the stability of the generators, and minimize the loss of the economy, this paper can recommend planned preventive maintenance, stringent monitoring schedule, and thorough documentation,

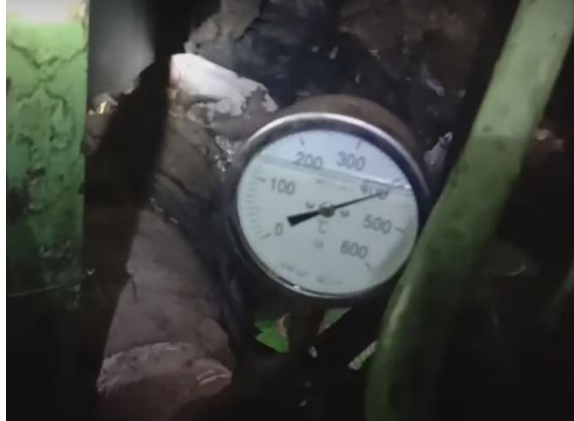
Figure 3. Fuel oil pump

The first signs of the fault had taken place, as the exhaust temperature increased above the normal operating range of about 370°C to a high temperature range of 420°C. This drastic increase in temperature instantly sounded a High Exhaust Gas Temperature alarm in the engine control room. Additional inspection of the visual and physical nature showed that there was a serious malfunction of the Bosch-type fuel oil pump, but it was located in the area of the fuel delivery control system. It was found that the fuel rack failed to go back to idle position after actuation, which was the direct cause of dire overfueling in the third cylinder.

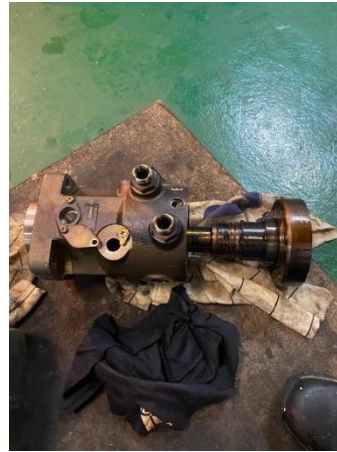
Figure 4. Fuel oil pump

To get to the bottom of the jammed rack, in-depth investigation work was carried out on the Bosch pump that was attached to the cylinder in question. This further investigation indicated as significant mechanical wear and internal failure to the Bosch injection pump itself. Specifically, technicians discovered extensively worn plunger-barrel and a severely clogged delivery valve. Ultimately, these compounding mechanical problems limited movement of the component, which resulted in incomplete combustion, and the highly localized exhaust gas temperature elevation observed in cylinder number three.
