Analysis of Freon Leak Identification and Repair in Refrigerator Piping System on MT GAS ALTHEA Ship

Citation: Ridwan., Winarno., Hasan. Analysis of Freon Leak Identification and Repair in Refrigerator Piping System on MT GAS ALTHEA Ship. *Jurnal Andromeda*, 10(1), 87-96. DOI: <https://dx.doi.org/10.48192/ard.v10i1.882>

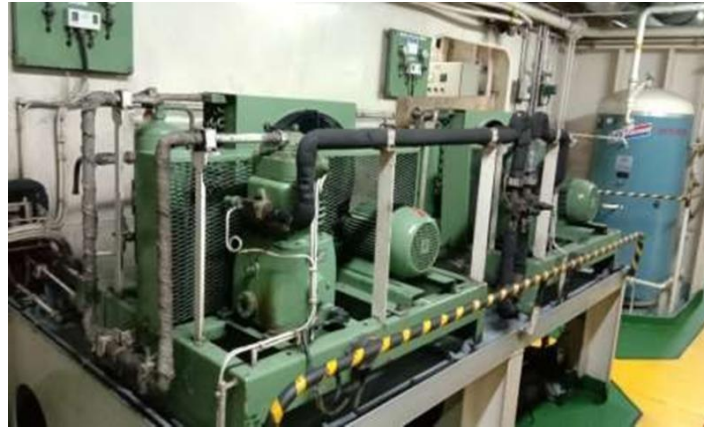
Figure 3. Foodstuff Cooling Machine
Source: MT. GAS ALTHEA

To detect the location of the leak, two methods were carried out, namely an examination with an electronic leak detector which found two active leak points at a rate of 0.3 grams per hour, and a pressure test with nitrogen which lowered the pressure from 90 psi to 84 psi for 4 hours. The leakage point is detected at the pipe connection near the expansion valve experiencing wear due to vibration, and the pipe near the receiver dryer is experiencing mild corrosion due to environmental humidity.
