THE CAUSE OF THE LOADING DELAY WAS DUE TO A PROBLEM WITH THE CARGO PUMP AT MT. SNAPPER

*Antonio Herbert Mangiri¹, Welem Ada², Muhammad Rifani³,

¹ Diploma IV Program, Politeknik Pelayaran Makassar, Makassar, Indonesia

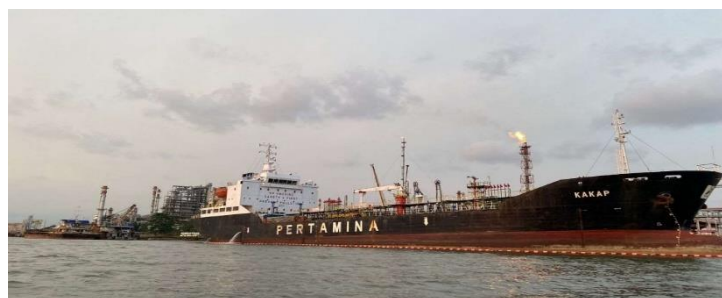
Figure 1. MT. SNAPPER

MT Kakap is an oil tanker owned by PT *Pertamina Internasional Shipping* which was built at the PT. DOK & Shipping Surabaya in Indonesia in 2012. This ship, also known as Kakap/N.08602, has specifications as an oil tanker with a capacity of around 6,500 tons. The ship has a length of 108 meters and a draft depth of 9.30 meters, using a double hull design that was common at the time of its construction.
